**Flood Control Project Maintenance  
Levee Inspections**

## Maintenance Issue Types Only, Levee Inspection Report By Mile - Spring 2017

### Knights Landing Ridge Drainage District

Waterway	Bank	Unit Miles	Inspection Start/End	Inspector
Unit No. 01 Knights Landing Ridge Cut	Right	6.36	05/02/2017 05/02/2017	Zach Jojola

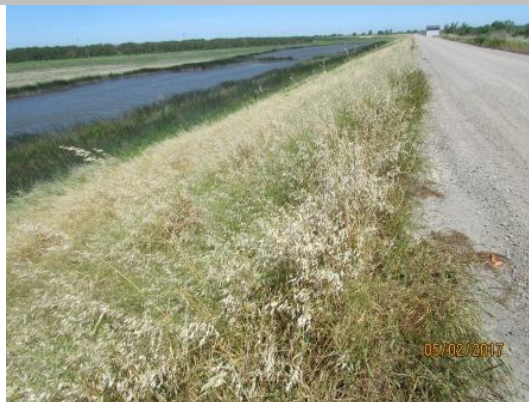
Photo 1 of 1 : SP\_2017\_NA0008\_256\_36\_20170502\_00052.jpg

LM Start	0.01	Rating **	U	Issue No.	36
LM End	1.50	Issue Type +	Ma	Location *	LS
Category	Earthen Levee			GPS Latitude/Longitude	
				Start	End
Item	Vegetation			38.719232°	38.734291°
				-121.664178°	-121.683015°
DWR ID	DWR_NA0008_01_s_2017_36				
Comment Code					
V1 : Control annual grass and weeds on the levee slopes and easements.					
Inspector Comment

Tall grass on landside levee slope, blocking visibility. Spring 2017.

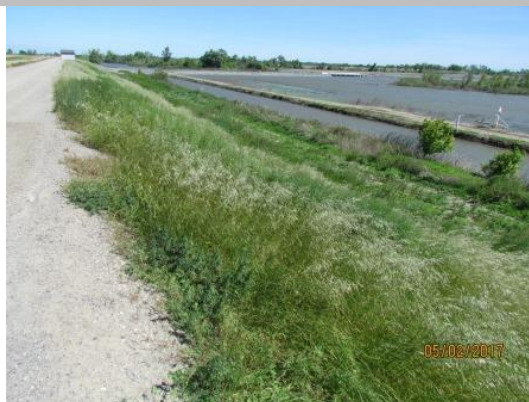
Photo 1 of 1 : SP\_2017\_NA0008\_256\_37\_20170502\_00053.jpg

LM Start	0.01	Rating **	U	Issue No.	37
LM End	1.57	Issue Type +	Ma	Location *	WS
Category	Earthen Levee			GPS Latitude/Longitude	
				Start	End
Item	Vegetation			38.719232°	38.735153°
				-121.664178°	-121.683813°
DWR ID	DWR_NA0008_01_s_2017_37				
Comment Code					
V1 : Control annual grass and weeds on the levee slopes and easements.					
Inspector Comment

Tall grass on waterside levee slope, blocking visibility. Spring 2017.

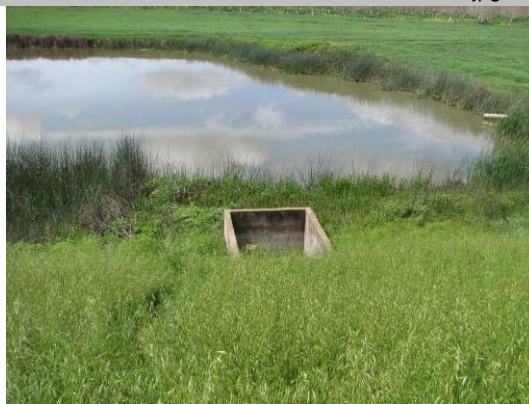
Photo 1 of 3 : UCIP\_SP\_2017\_48010\_21582.jpg

Concrete distribution box on LS toe.

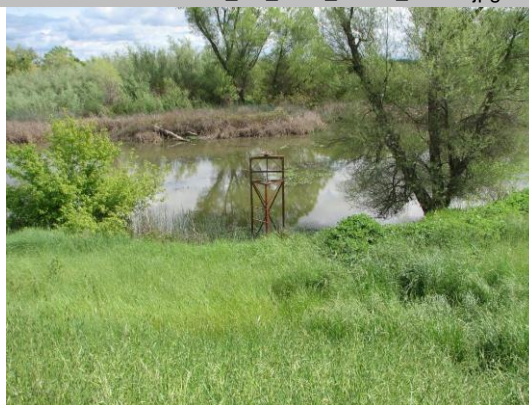
Photo 2 of 3 : UCIP\_SP\_2017\_48010\_21581.jpg

Slide gate on metal stand on WS toe. Pipe opening not visible.

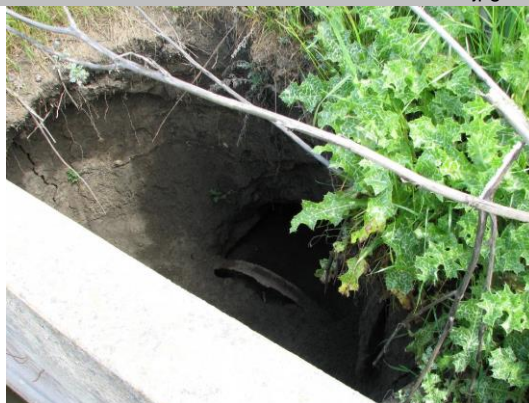
Photo 3 of 3 : UCIP\_SP\_2017\_48010\_21580.jpg

Comment Code					
Inspector Comment					
FS_ID:48010 DS_ID:19360 EP_NO: 9302 Repair Type: No Action Needed Crossing Status: Found UCIP Comments: Pipe has been grouted in place under permit 18987, 2015Pipe completely rusted through on LS slope of levee at toe/headwall of concrete distribution box. Pipe needs replacement or proper abandonment. Pipe not visible at outlet. FIELD_STRUCT_DESC: *ABANDONED* 36-inch pipe through the levee, 27.0 feet below the crown. Slide gate on the waterward end. 12'X6' Concrete box on the landward end (Permit No. 9302-Elliott). Abandoned by removing ends and pumping pipe full of concrete (Permit No. 18987, 2015). O&M Manual 127, June 1953. FS Date: 5/16/2016 3:59:29 PM

Pipe failure at connection to concrete box on LS toe.

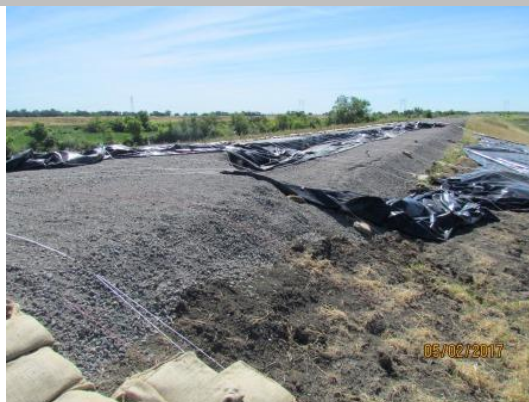
Photo 1 of 2 : SP\_2017\_NA0008\_256\_32\_20170502\_00049.jpg

LM Start	2.24	Rating **	M	Issue No.	32
LM End	2.24	Issue Type +	Ma	Location *	LS
Category	Earthen Levee			GPS Latitude/Longitude	
				Start	End
Item	Slope Stability			38.743013 °	38.743013 °
				-121.691004 °	-121.691004 °
DWR ID	DWR_NA0008_01_s _ 2017_32				
Comment Code					
S1 : Repair slope instability.					
Inspector Comment					
100' section of sloughing on crown and landside levee slope. LMA placed visqueen, sandbags, and twine to prevent further erosion.

View of of sloughing on crown and landside levee slope. Spring 2017.

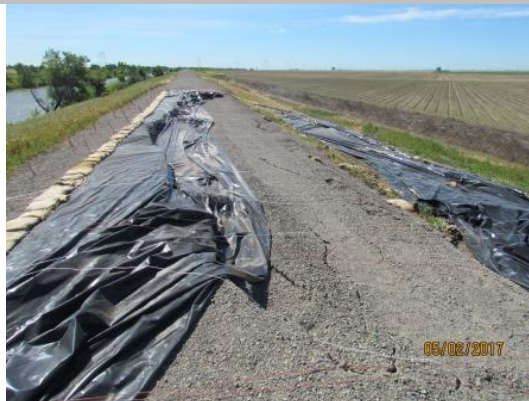
Photo 2 of 2 : SP\_2017\_NA0008\_256\_32\_20170502\_00051.jpg

LM Start	2.24	Rating **	M	Issue No.	32 (cont)	
LM End	2.24	Issue Type +	Ma	Location *	LS	
Category	Earthen Levee			GPS Latitude/Longitude		
				Start		End
Item	Slope Stability			38.743013 °		38.743013 °
				-121.691004 °		-121.691004 °
DWR ID	DWR_NA0008_01_s_2017_32					
Comment Code						
S1 : Repair slope instability.						
Inspector Comment						
100' section of sloughing on crown and landside levee slope. LMA placed visqueen, sandbags, and twine to prevent further erosion.

Addition view of sloughing. Spring 2017.

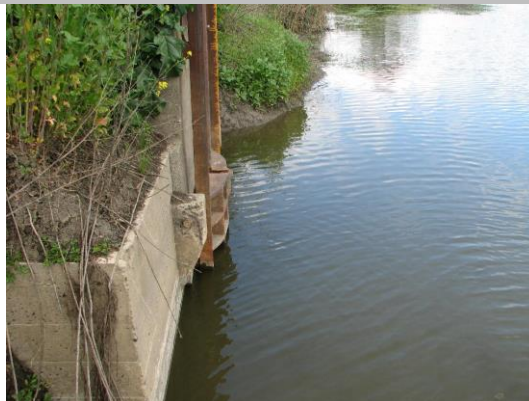
Photo 1 of 3 : UCIP\_SP\_2017\_13205\_21602.jpg

FS\_ID:13205  
DS\_ID:19391  
EP\_NO: 9307  
Repair Type: Non-Urgent  
Crossing Status: Found  
UCIP Comments: Walkway to actuator slide gate is missing. No method of actuating slide gate.  
FIELD\_STRUCT\_DESC: 2 of 2: 4-foot x 4-foot concrete box culvert through the levee, 23 feet below the crown. Walkway to slide gate on the waterside end, concrete headwalls on both ends. Service pole and anchor at landward toe. Concrete headwalls on both ends (Permit No. 9307- Lowe).  
FS Date: 4/5/2013

Slide gate and concrete headwall on WS toe.

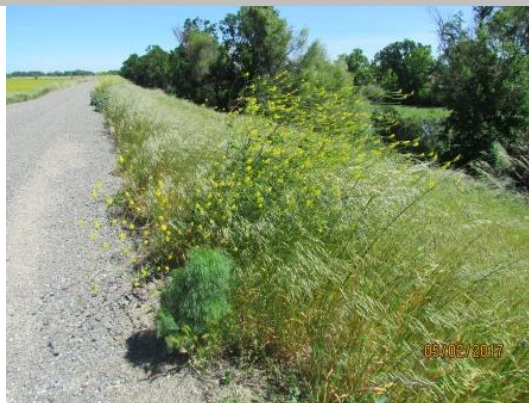
Photo 1 of 1 : SP\_2017\_NA0008\_256\_39\_20170502\_00055.jpg

Tall grass on waterside levee slope, blocking visibility. Spring 2017.

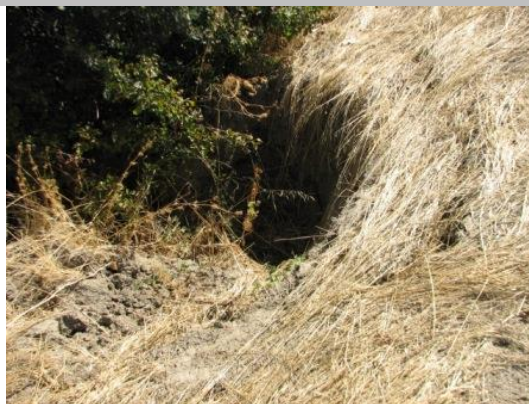
Photo 1 of 2 : SP\_2017\_NA0008\_256\_20\_20170320\_00007.jpg

LM Start	3.50	Rating **	U	Issue No.	20
LM End	3.50	Issue Type +	Ma	Location *	WS
Category	Earthen Levee			GPS Latitude/Longitude	
				Start	End
Item	Erosion / Bank Caving			38.759910 °	38.759910 °
				-121.696920 °	-121.696920 °
DWR ID	DWR_NA0008_01_f_2015_20				
Comment Code					
E2 : Schedule repair of erosion site prior to the next inspection.					
Inspector Comment

Deep erosion at the bottom of the waterside slope 3-4 foot cut. Fall 2013

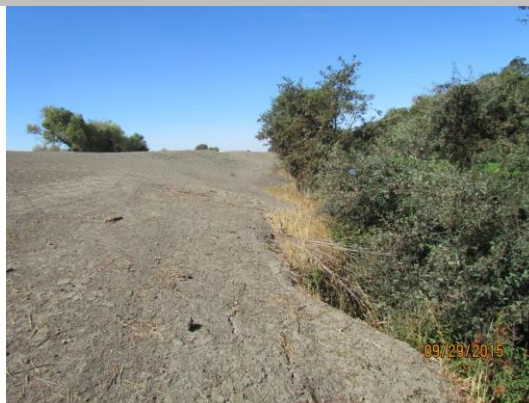
Photo 2 of 2 : SP\_2017\_NA0008\_256\_20\_20170320\_00008.jpg

LM Start	3.50	Rating **	U	Issue No.	20 (cont)	
LM End	3.50	Issue Type +	Ma	Location *	WS	
Category	Earthen Levee			GPS Latitude/Longitude		
				Start		End
Item	Erosion / Bank Caving			38.759910 °		38.759910 °
				-121.696920 °		-121.696920 °
DWR ID	DWR_NA0008_01_f_2015_20					
Comment Code						
E2 : Schedule repair of erosion site prior to the next inspection.						
Inspector Comment

View of the erosion on the waterward side of the levee looking upstream. Fall 2015.

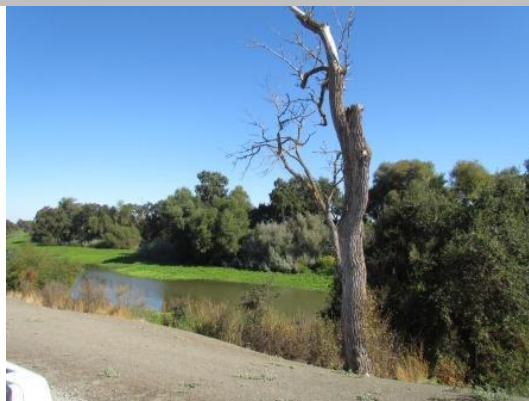
Photo 1 of 1 : SP\_2017\_NA0008\_256\_15\_20170320\_00003.jpg

View of an old tree on waterward side of the levee. Subject to monitor. Fall 2016.

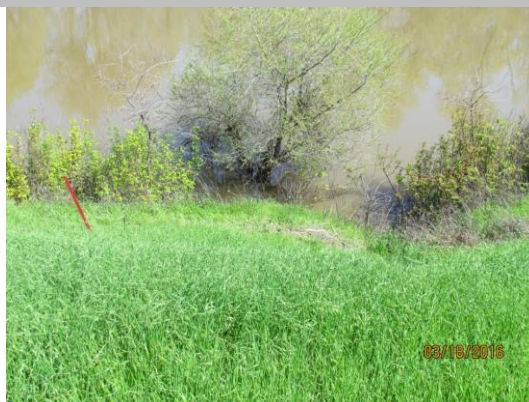
Photo 1 of 1 : SP\_2017\_NA0008\_256\_31\_20170320\_00015.jpg

LM Start	3.86	Rating **	M	Issue No.	31
LM End	3.86	Issue Type +	Ma	Location *	WS
Category	Earthen Levee			GPS Latitude/Longitude	
				Start	End
Item	Erosion / Bank Caving			38.763751 °	38.763751 °
				-121.701398 °	-121.701398 °
DWR ID	DWR_NA0008_01_s_2016_31				
Comment Code					
E1 : Note and monitor erosion site.					
Inspector Comment					
Erosion at the toe of the levee. LMA is monitoring erosion with stakes.

View of the erosion at the toe of the levee on the waterward side. Spring 2016.

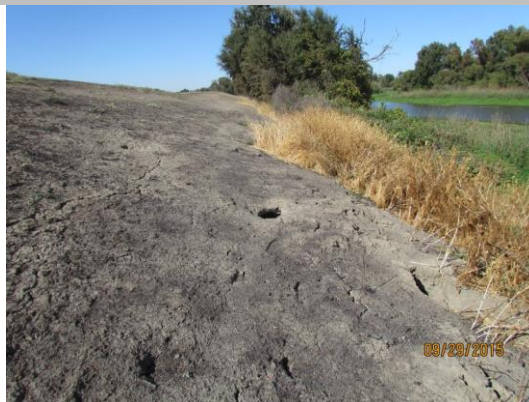
Photo 1 of 1 : SP\_2017\_NA0008\_256\_21\_20170320\_00009.jpg

View of the rodent holes on the waterward side of the levee looking upstream. Fall 2015.

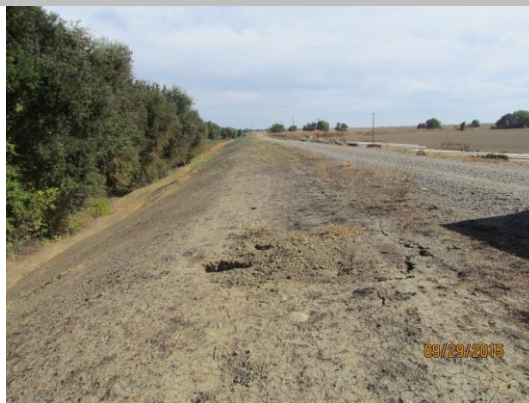
Photo 1 of 1 : SP\_2017\_NA0008\_256\_24\_20170320\_00011.jpg

View of the rodent holes on the waterward side of the levee looking downstream. Fall 2015.

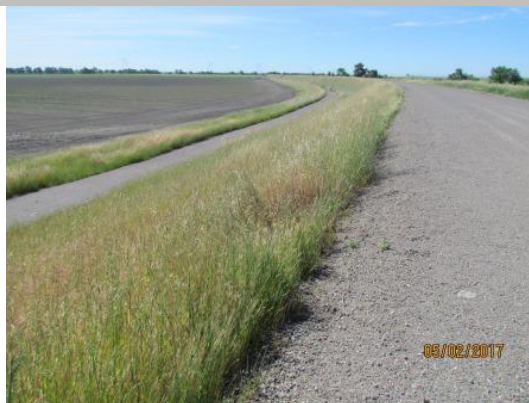
Photo 1 of 1 : SP\_2017\_NA0008\_257\_24\_20170502\_00029.jpg

Tall grass on landside levee slope, blocking visibility. Spring 2017.

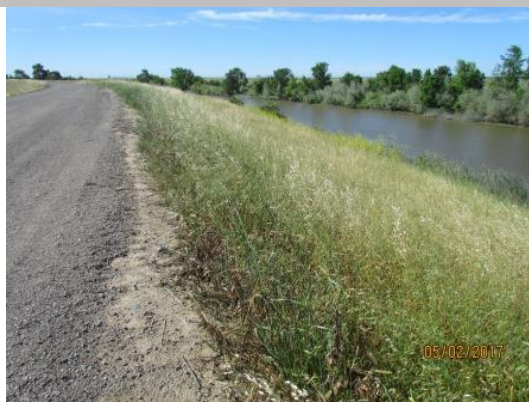
Photo 1 of 1 : SP\_2017\_NA0008\_257\_26\_20170502\_00030.jpg

LM Start	0.00	Rating **	U	Issue No.	26
LM End	2.26	Issue Type +	Ma	Location *	WS
Category	Earthen Levee			GPS Latitude/Longitude	
				Start	End
Item	Vegetation			38.724264 °	38.748280 °
				-121.665315 °	-121.692666 °
DWR ID	DWR_NA0008_02_s_2017_26				
Comment Code					
V1 : Control annual grass and weeds on the levee slopes and easements.					
Inspector Comment

Tall grass on waterside levee slope, blocking visibility. Spring 2017.

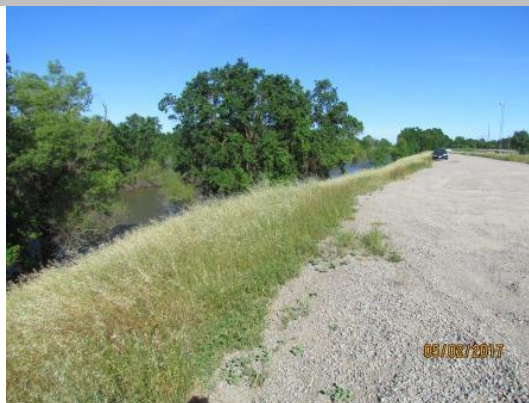
Photo 1 of 1 : SP\_2017\_NA0008\_257\_17\_20170502\_00028.jpg

Tall grass on landside levee slope, blocking visibility. Spring 2017.

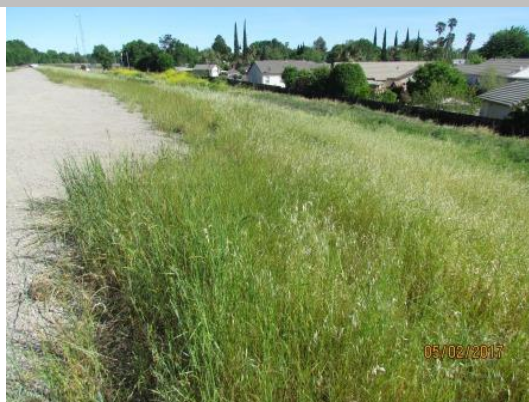
Photo 1 of 1 : SP\_2017\_NA0008\_257\_15\_20170502\_00027.jpg

LM Start	2.30	Rating **	U	Issue No.	15
LM End	5.94	Issue Type +	Ma	Location *	LS
Category	Earthen Levee			GPS Latitude/Longitude	
				Start	End
Item	Vegetation			38.748868 °	38.792633 °
				-121.692798 °	-121.724011 °
DWR ID	DWR_NA0008_02_s_2017_15				
Comment Code					
V1 : Control annual grass and weeds on the levee slopes and easements.					
Inspector Comment

Tall grass on landside levee slope, blocking visibility. Spring 2017.

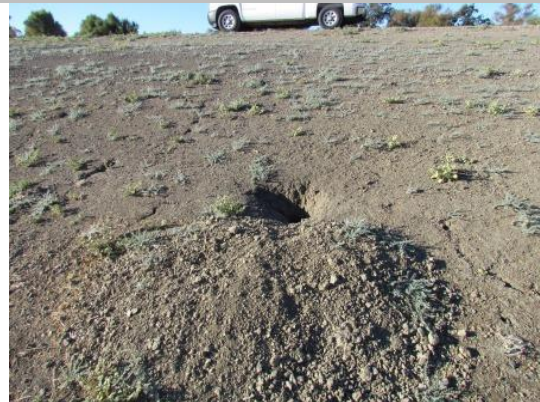
Photo 1 of 1 : SP\_2017\_NA0008\_257\_13\_20170320\_00002.jpg

View of a rodent hole on LS slope. Fall 2016.

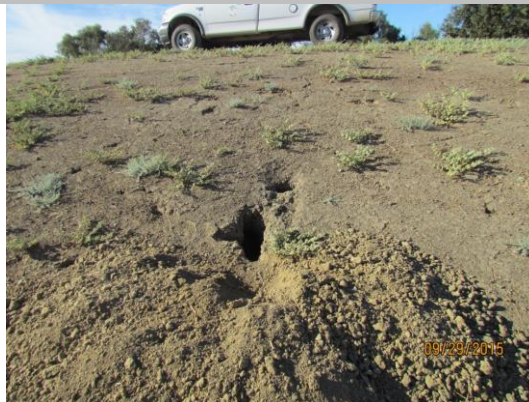
Photo 1 of 2 : SP\_2017\_NA0008\_257\_16\_20170320\_00003.jpg

There seems to be more than 2 cubic feet of material on the landward side of the levee. Fall 2015.

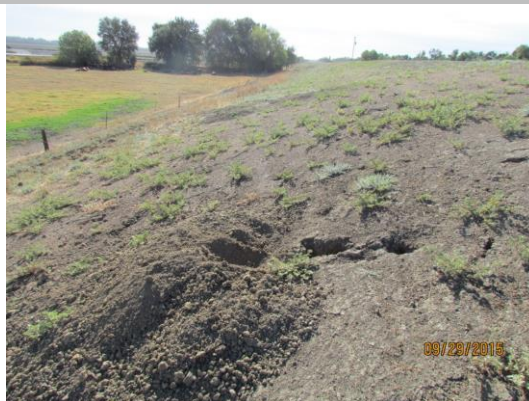
Photo 2 of 2 : SP\_2017\_NA0008\_257\_16\_20170320\_00004.jpg

Perspective view of the animal hole on the landward side of the levee looking downstream. Fall 2015.
